VISUAL BUILDING INSPECTION REPORT

8/8/2008.

8 Beach Rd, Beachville.

This report complies with Australian Standard AS 4349.1 - 2007 Inspection of Buildings.

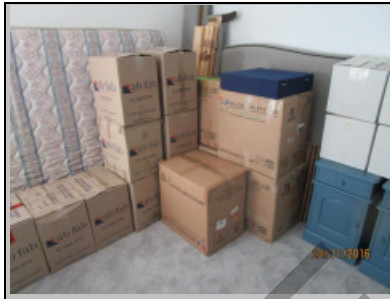
Stored goods were blocking full visibility.

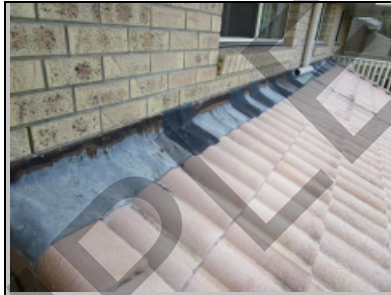
Flashing material is of lead. The lead flashing is split & requires repair or replacement.

A licensed roof plumber should be called to make a further evaluation and repairs or rectification as needed.

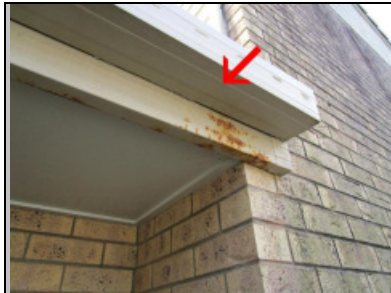
The gutters and down pipes are rusted and should be repaired or replaced as necessary.

A Licensed plumber should be called to make a further evaluation and repairs or rectification as needed.

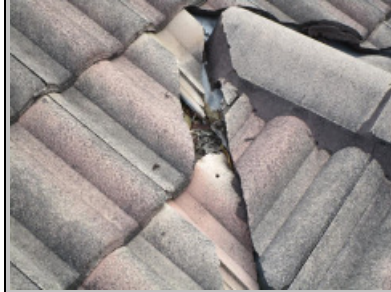
The overall condition of the valley metal is fair. Loose tiles are present & should be re set in position.

A licensed roofing contractor should be called to make a further evaluation and repairs or rectification as needed.

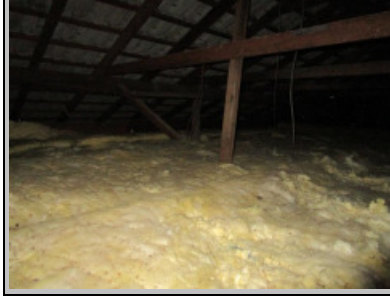
Batts are installed to the property.

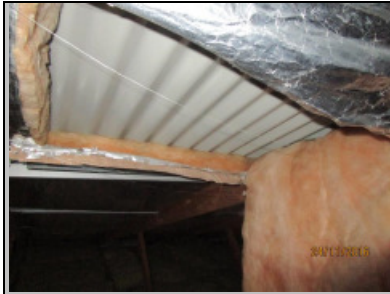
Sarking is present but is torn or has holes in some areas. This may affect the waterproofing ability of the sarking and this should be repaired.

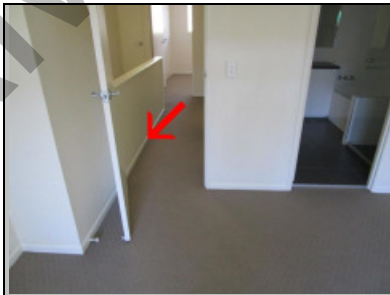
Hallway:

The condition of the walls is generally fair. Evidence of what appears to be termite attack was noted. Due to timber pest damage, some timber replacement may be required. The full extent of timber damage and/or replacement cannot be determined during a visual inspection and a more invasive inspection is required.

A licensed builder should be called to make a further evaluation and repairs or rectification as needed.

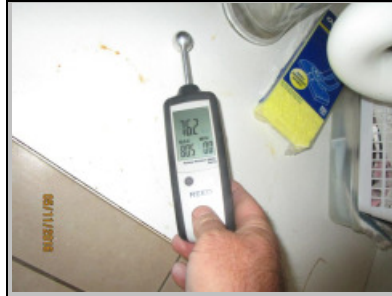
Some leakage was noted at the drain.

A Licensed plumber should be called to make a further evaluation and repairs or rectification as needed.

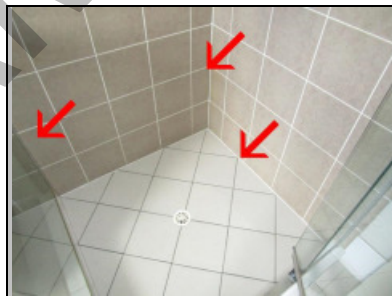
The condition of the tiles is generally good. Recommend to implement an ongoing maintenance program with silicone sealants to ensure all wet areas are kept water tight.

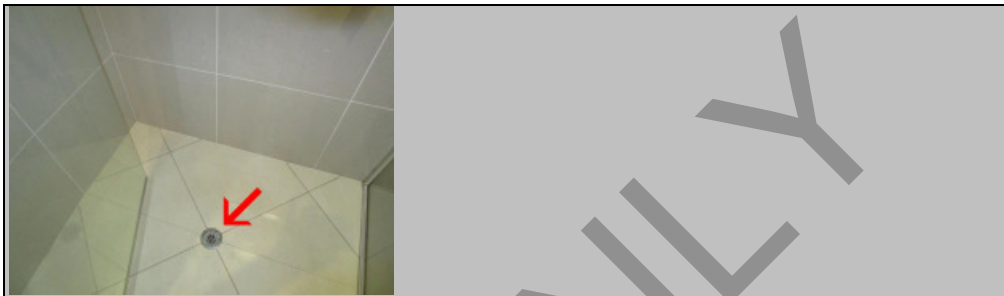
There is not adequate fall on the shower floor for water to flow to the waste pipe. This can allow water to pond causing leaks. A licensed builder should be consulted in relation to rectification costs.

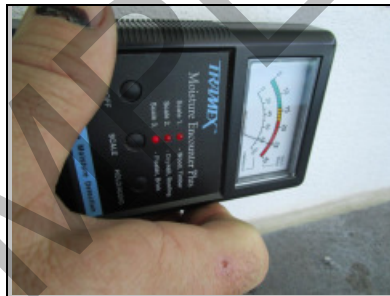
The condition of the walls is generally fair. High moisture reading. recommend to further investigate.

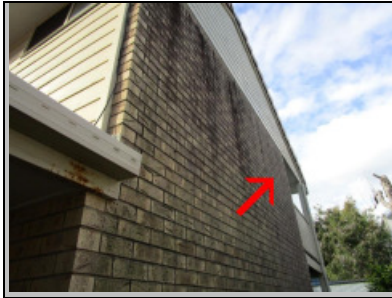
Cracks are evident. Visible cracking has been categorized as a structural defect. Cracking of a building element is a structural defect where in the opinion of the inspector the structural performance of the building element is impaired, or where the cracking is the result of the structural behavior of the building. The expected consequence of this cracking is unknown until further information is obtained.

This must be referred to a Structural Engineer to investigate.

A licensed builder should be called to make a further evaluation and repairs or rectification as needed.

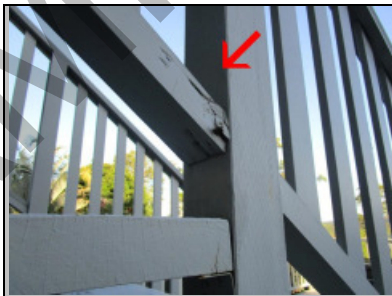
Moderate wood decay is present to the structure. Some repairs or maintenance will be required.

A licensed carpenter should be called to make a further evaluation and repairs or rectification as needed.

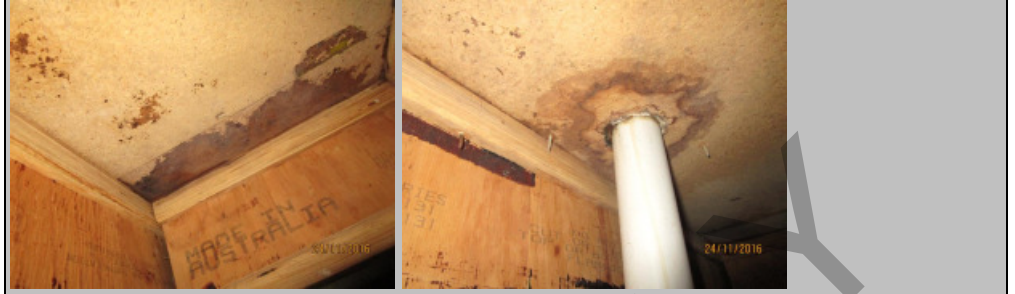
Staining and high moisture readings to floor below bathrooms. Recommend this is further investigated.

A licensed builder should be called to make a further evaluation and repairs or rectification as needed.

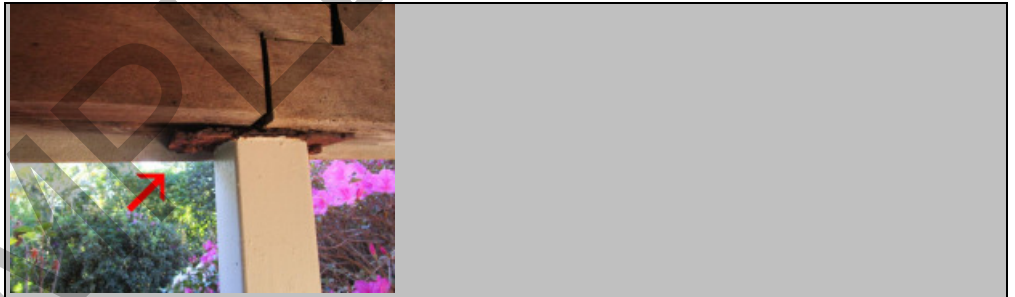
The under floor soil is damp. This may be due to a drainage problem or some other factor. This area should be further investigated.. Rust noted to top of post. This should be replaced.

A licensed builder should be called to make a further evaluation and repairs or rectification as needed.
