Storm Damage Report

3 Kessler St, Baringa

3945H

VISUAL BUILDING INSPECTION REPORT

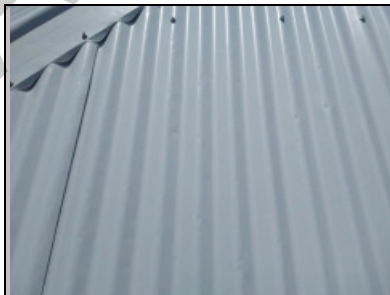
Widespread hail damage to entire roof.

Refer to your insurance company.

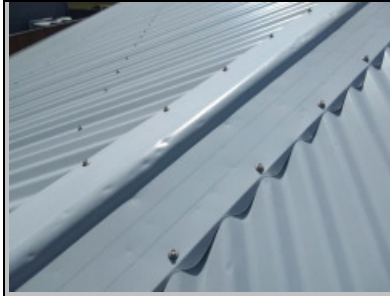
Widespread hail damage.

Refer to your insurance company.

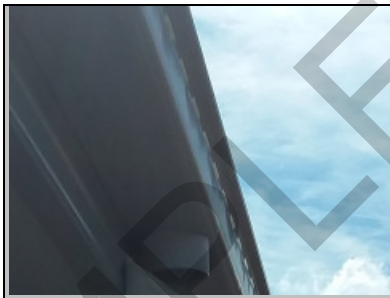
Hail damage noted to guttering.

Refer to insurance company.

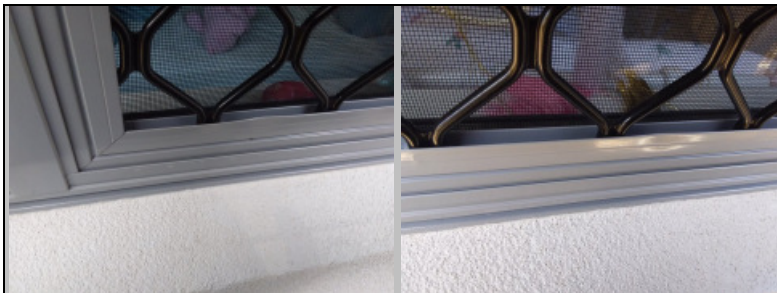
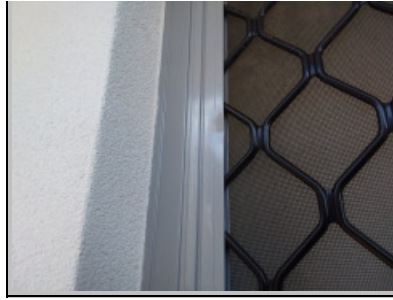
Impact damage to security screens noted.

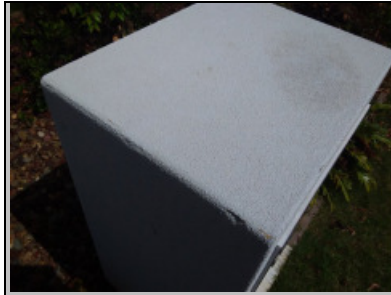
Damage noted to letterbox.

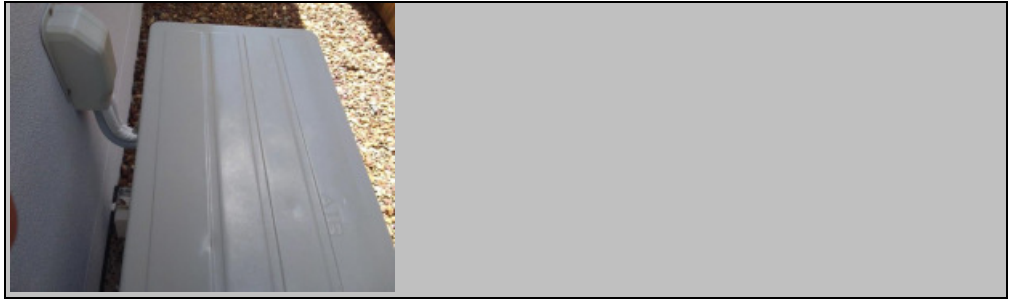
Hail damage to the top of air conditioning unit. Left side.

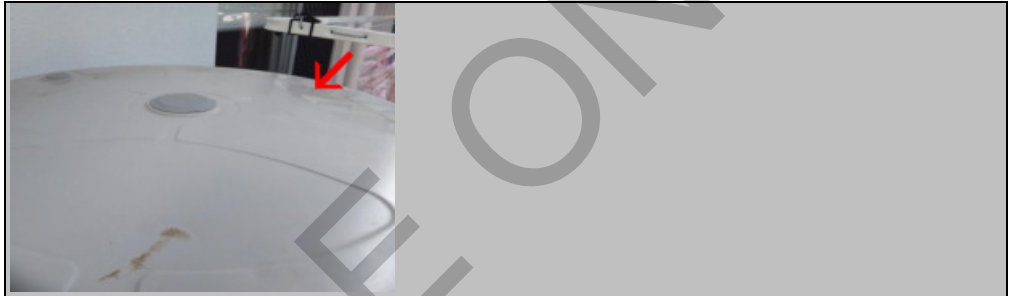
Hail damage to the top of the hot water unit.
