# Building Report

1 New St, Sunshine Coast

3967HO

# VISUAL BUILDING INSPECTION REPORT

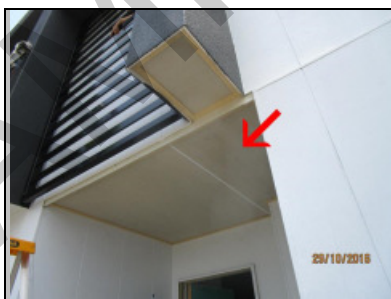
The eaves are lined with fibre cement sheeting. Painting incomplete, recommend to finish painting.

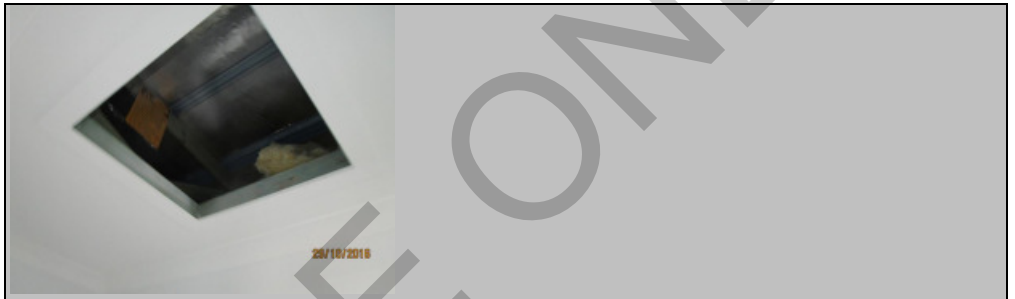
Areas marked with blue tape.

The condition of the ceilings is generally good. Patching & or painting required to the following areas. Man hole cover was missing.

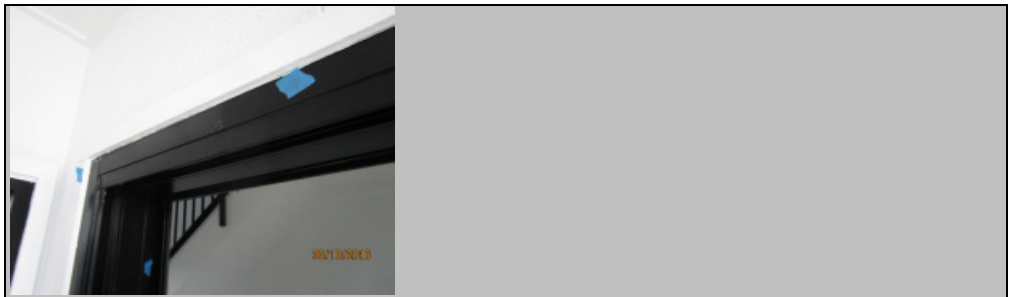
The condition of the windows is generally good. Over spray noted to some sliders. Refer to builder to clean all windows internally before final hand over.

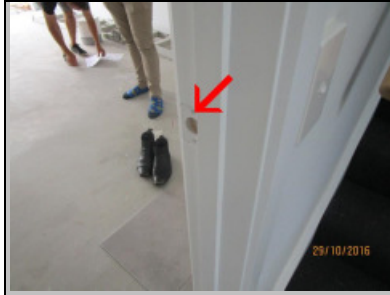
As marked with blue tape.

The condition of the doors is generally good. Patch & or Painting touch ups required to the following areas. Some components missing like striker plates.

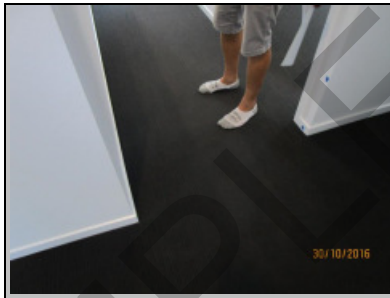
upstairs front unit.

The condition of the floors is generally good. Squeaking flooring was noted. This will require re fixing to prevent movement. As floor coverings are present over this area, this work should be carried out when the floor coverings are next changed.

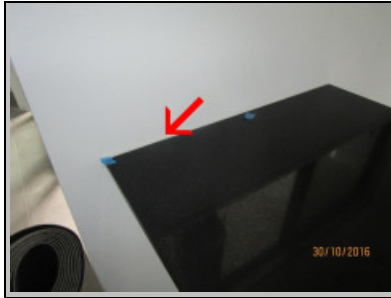
Sealants to edge of bench need re doing. Splashbacks not yet installed.

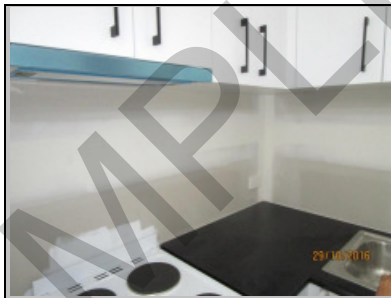
Splashback missing.

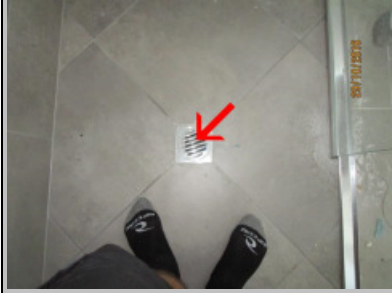
The drain pipe appears to require cleaning. Grout etc in pipe.

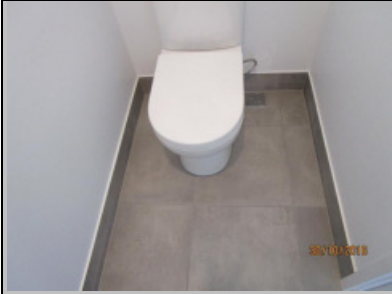
Adjacent to hall front house. Toilet is not center of the room?

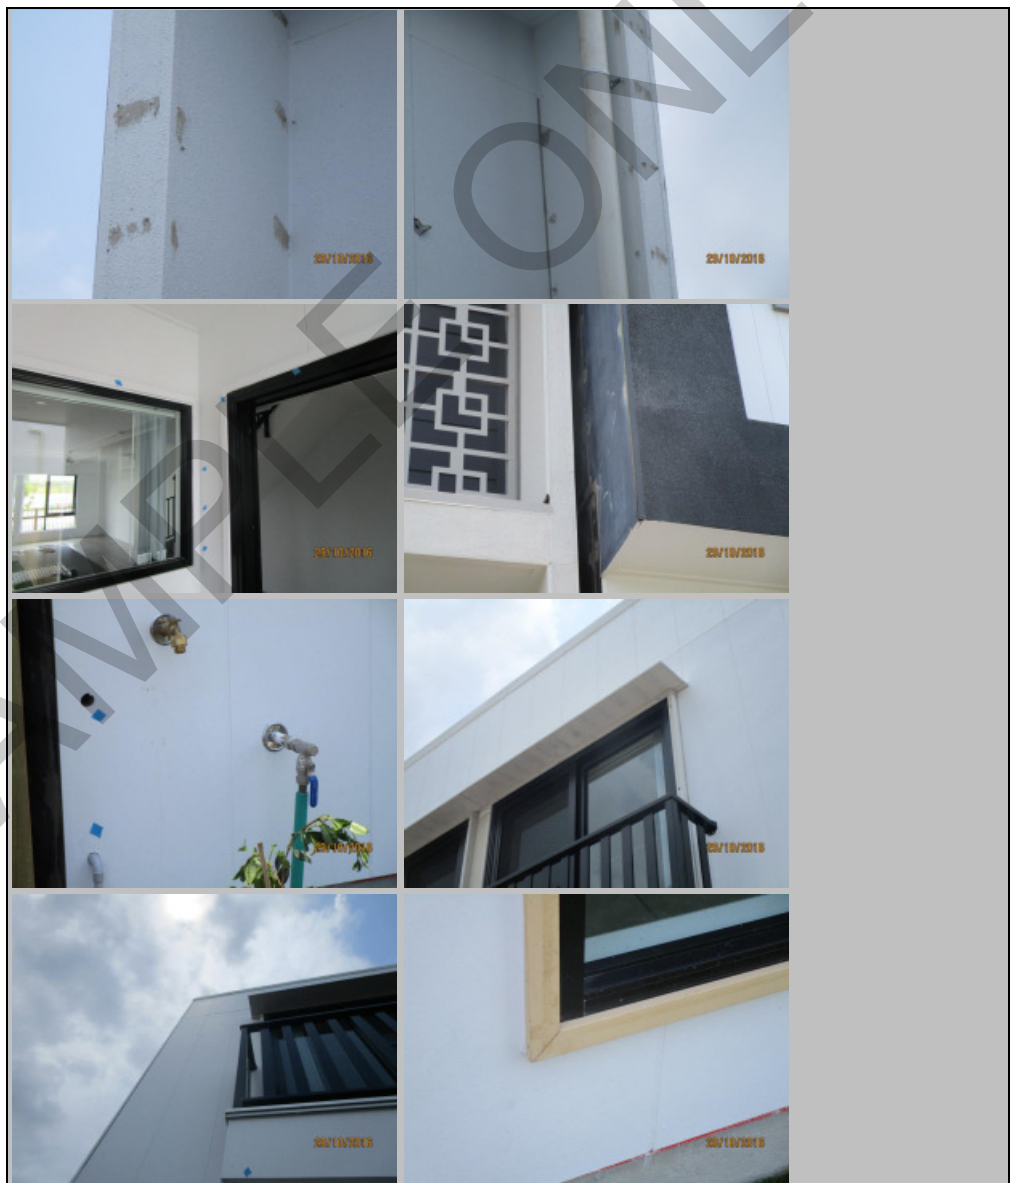
The cladding externally has a rough finish . The paintwork has been installed over dirt and lumps etc. This should be sanded back and re painted. Dings and bulges should be patched and re textured and painted. Some sections are not painted at all. Some sections of texture have missing sections of texture. This should be rectified. Exterior cladding to fire walls should be painted where visible,

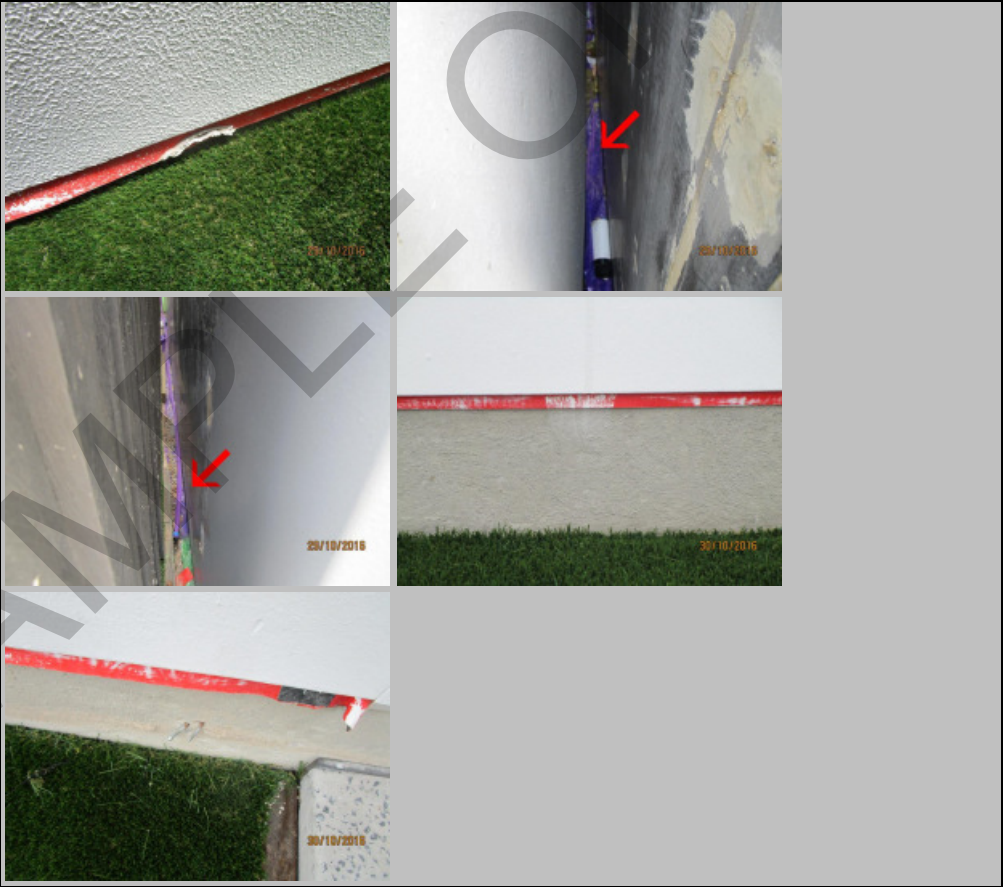
Kordon barrier should not be covered in paint etc. This will need to be cleaned off to avoid any warranty issues with Kordon. Termite Reticulation lines to boundary walls will need to be laid correctly in soil as per manufacturers guidelines.

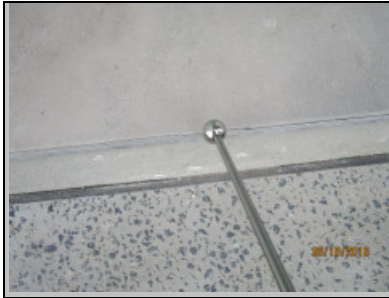
The structure is built from, Concrete. The general condition of this structure is good. Metal angle to slab edge is not supported and grout is cracking.

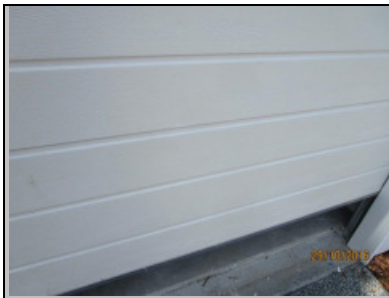
Hail damaged.

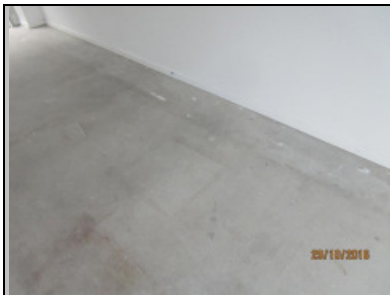
Slab requires a clean. Paint blobs etc.

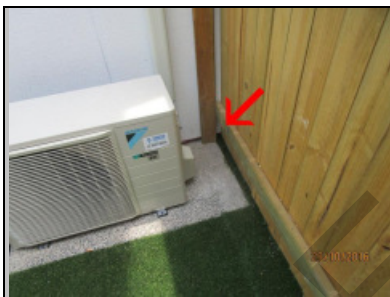
Recommend to cut post 75mm above ground so it does not breach Kordon.
