# Building Report

1 New St, Sunshine Coast

3967HO

# VISUAL BUILDING INSPECTION REPORT

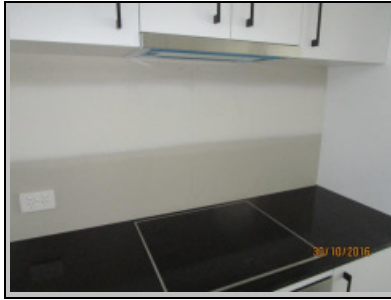
The condition of the fixtures is generally good.

Sealants to edge of bench need re doing. Splashbacks not yet installed.

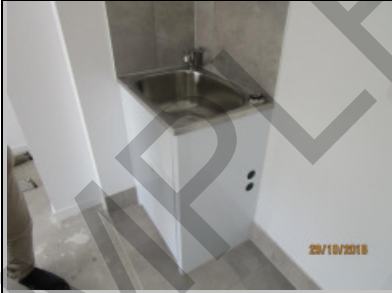
This area is generally in good condition.
